Under-testing of wind turbine blades above 60 meters length causes field structural issues

Bladena Whitepaper

March, 2024

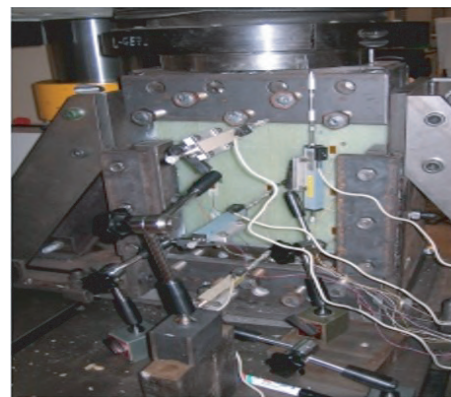
Figure 2 - In-plane compression test demonstrates the over capacity of in-plane strength, shown on Figure 3.

Composite materials in modern large wind turbine blades do not fail due to lack of in-plane strength, but rather due to out-of-plane panel deformations. By checking the material properties of glass fiber, it can be seen how the longitudinal in-plane strength varies from 16000µε in compression to 22000µε in tension (see Figure 3).

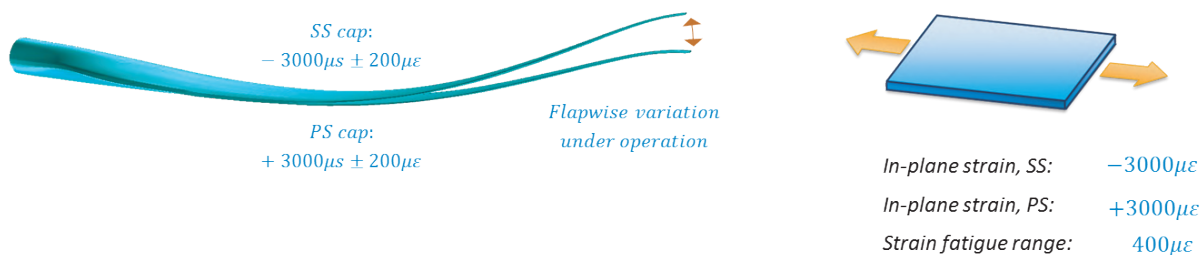
Figure 5 - Longitudinal strain values for a blade exposed to flapwise fatigue test as part of a certification test campaign.

Despite this large margin between field longitudinal in-plane strains and the material limit for glass fiber, expensive, and time consuming fatigue flapwise tests that strains in the longitudinal direction are still conducted [6]. The results from these full-scale tests show that longitudinal strain measurements peak around $5000\mu\epsilon$, see Figure 5. This represents approximately 60% increase over operational strains yet is significantly below what the material can withstand.

Furthermore, Figure 3 illustrates that the fatigue range is around $10000\mu\epsilon$ as the blade during the test moves towards the pressure side and then back towards the suction side. In operational conditions, aerodynamic forces tilt the blade towards the suction side, generating an oscillation range of around $400\mu\epsilon$ under “regular” operational conditions.
