Bladena

D-Tip™

Technical Documentation

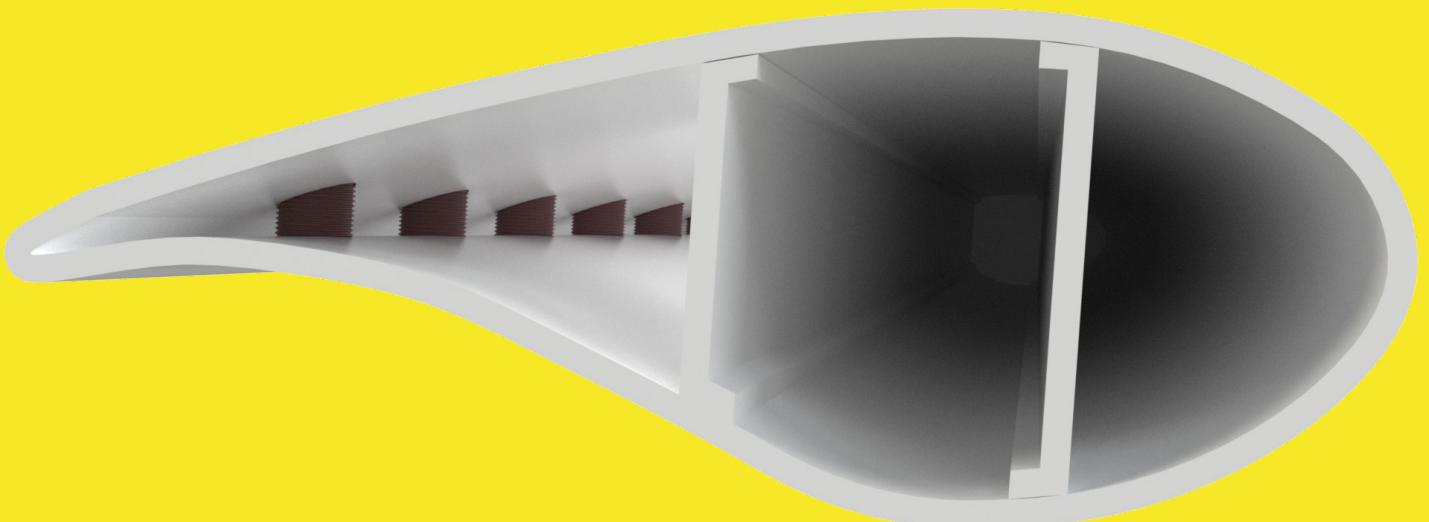
The D-Tip™ solution is a technology developed to address the tip opening issue of the wind turbine blade.

The solution connects the pressure side and suction side to prevent the detachment of the two shells of the tip, caused by the internal thermal expansion of the moist air inside the tip when a lightning strike hit the tip.

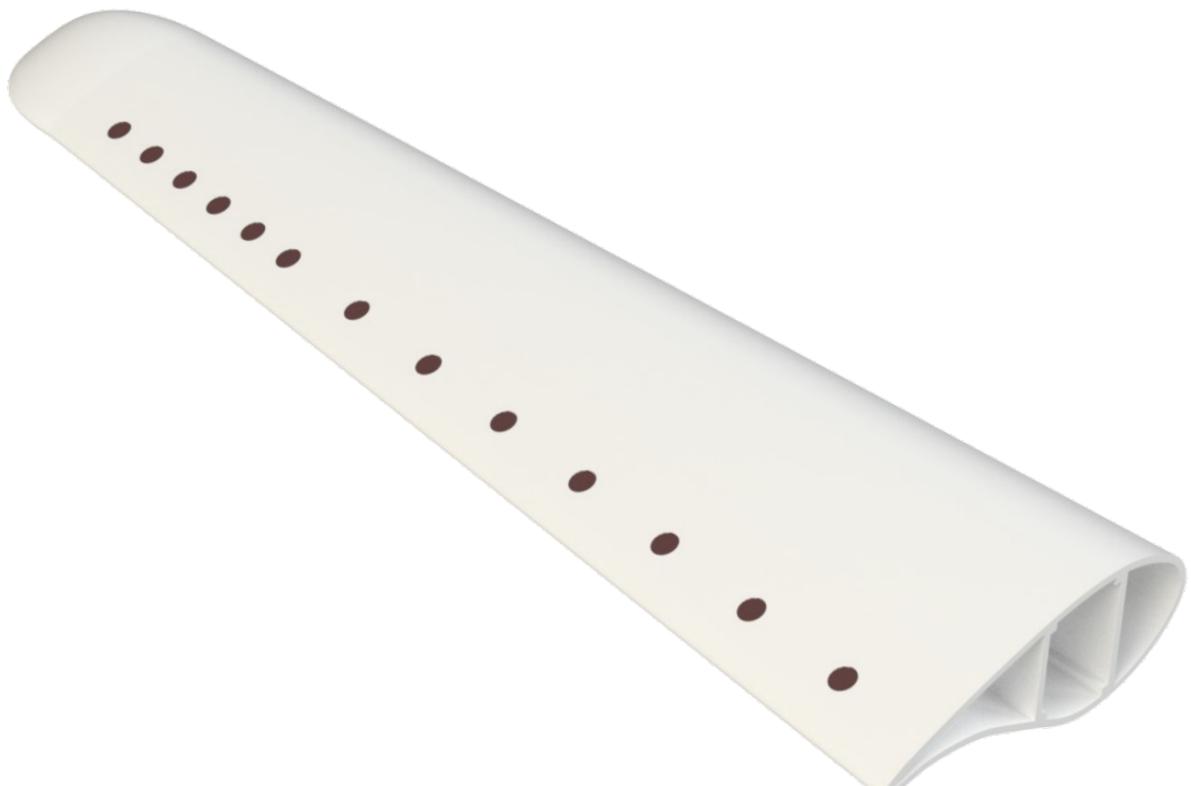
D-Tip™ Technical Description

The D-Tip™ is a designed solution aiming the root cause of tip openings. It comes as a retrofit kit, installed by Bladena certified technicians.

The D-Tip™ is designed as a strong yet light weight product, which makes it easy to install up-tower. The D-Tip™ is used for interim or preventative repair of tip damages caused by lightning.

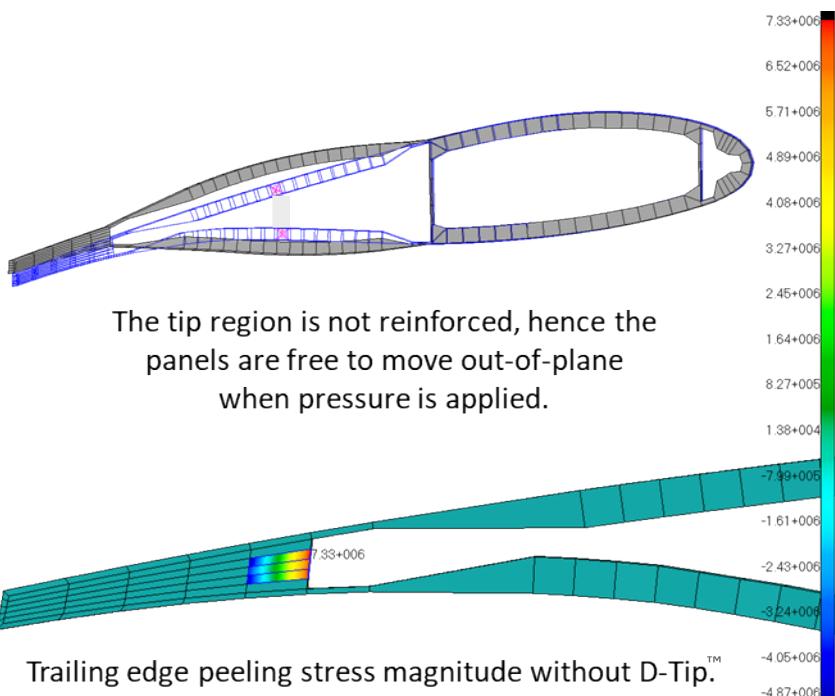
Without D-Tip™ installed

The D-Tip™ installation: Verified by a Numerical FEM Simulation

The D-Tip™ is installed in the tip region and a comparison of the blade with and without D-Tip™ with the same pressure applied is made.

Based on the simulation, installing the D-Tip™ in the tip region, trailing edge, will decrease the peeling stress level by approx. 70% when pressure from a lightning strike will deform the panels out-of-plane. The pressure applied in this scenario does not reflect the real-life situation. The comparison is only for the purpose to verify the D-Tip™ .

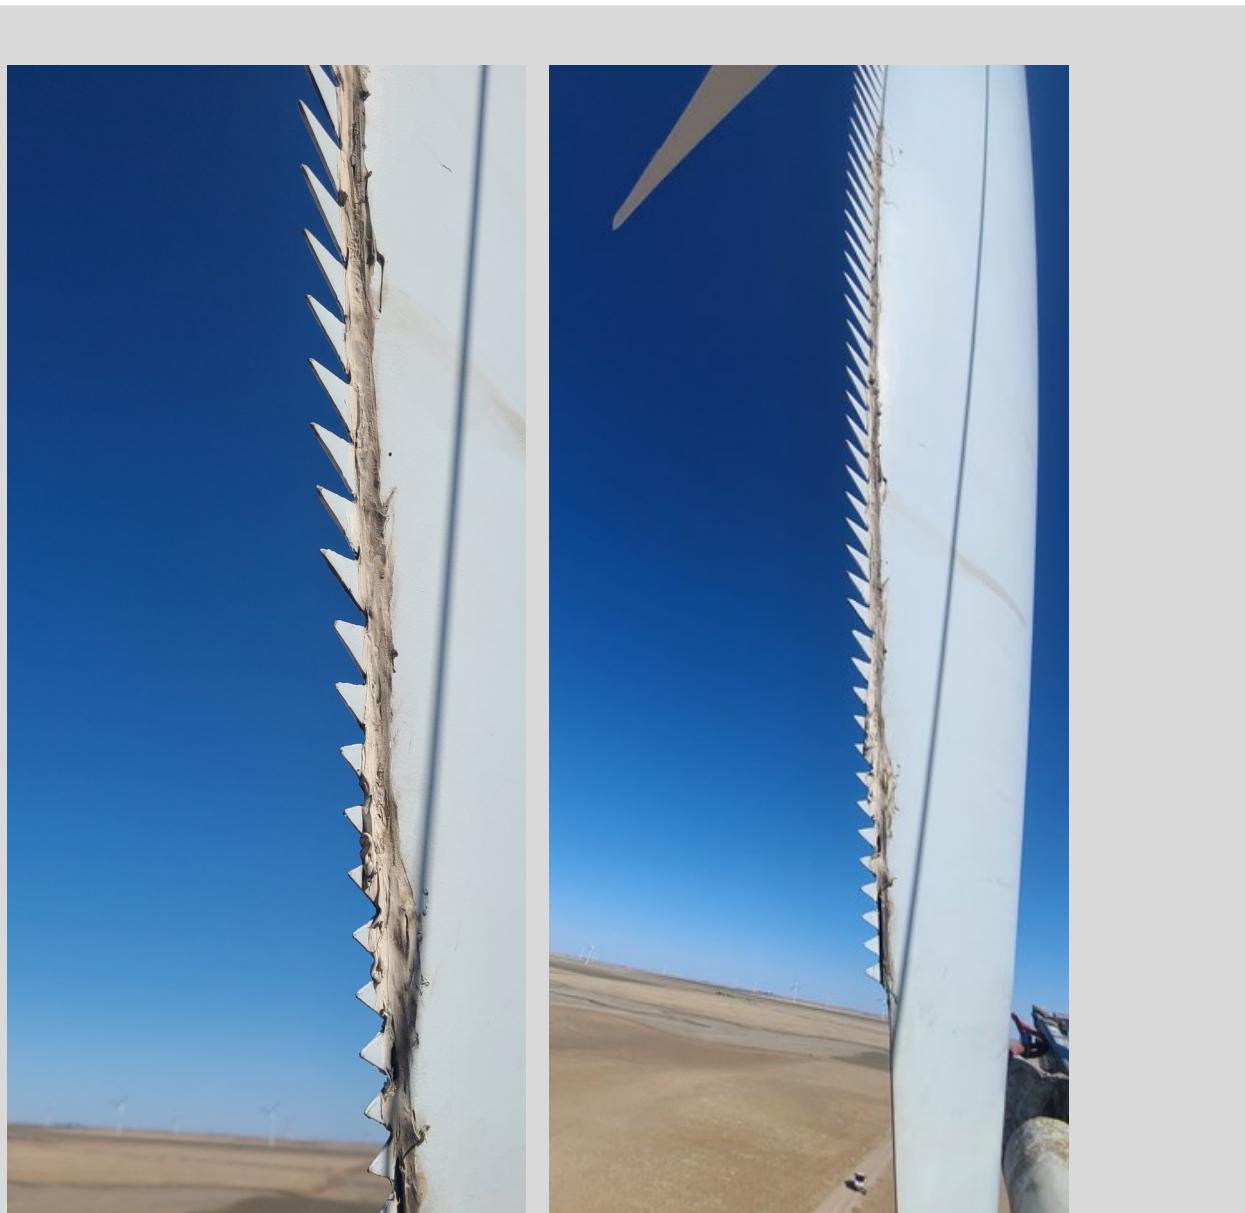
D-Tip™ field case validation

Length: 50.2m

The blade had approximately 0.5m of the pressure side shell at the tip torn away and liberated from a lightning strike.

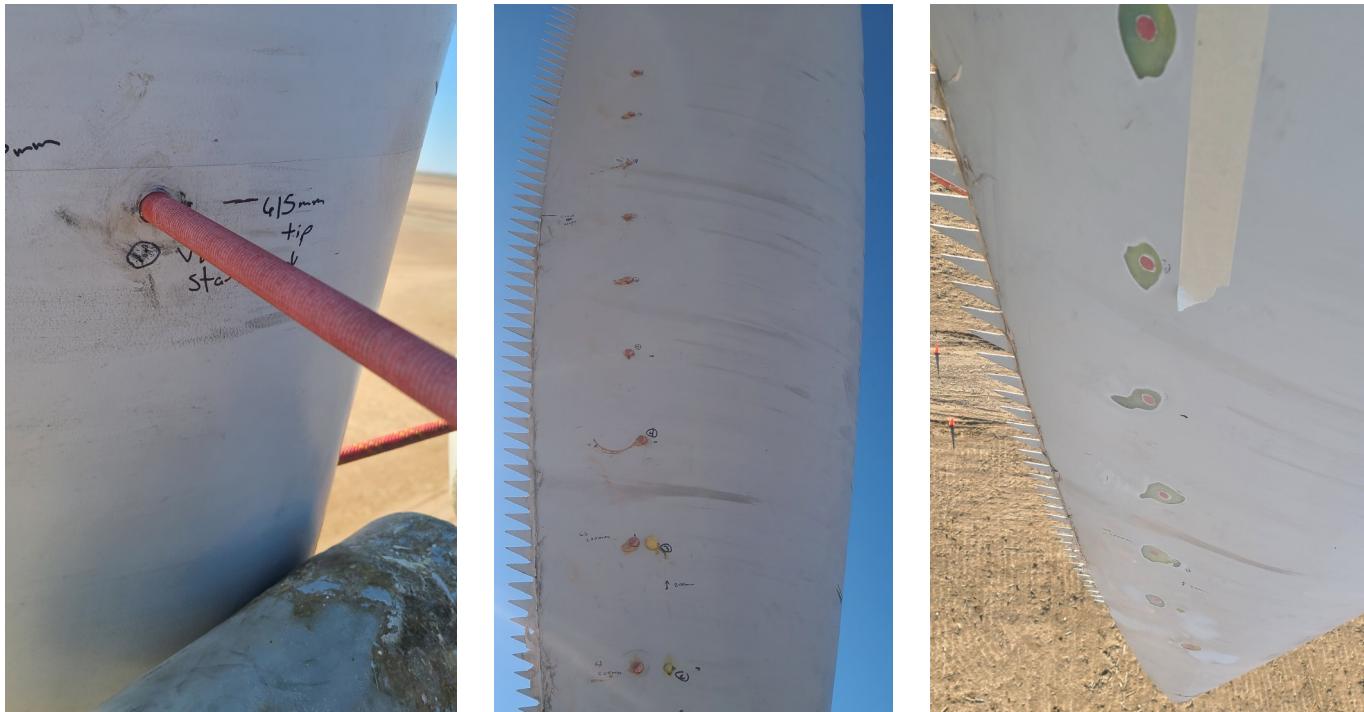
D-Tip™ field case - solution

D-Tip™

150mm below the start of the Split TE. Each marking is 200mm apart, towards the root, and 200mm away from the TE.

- Reduced repair time. The D-Tip™ only took 1/3rd time of the classical repair procedure.
- Utilized as a mechanical fix.
- Continuous operation in the period when a classical repair was not possible due to weather conditions.
