## Torsional Effects on Wind Turbine Blades and Impact on Field Damages

F. M. Jensen<sup>1</sup>, J. O. Arconada<sup>1</sup>, M. Werk<sup>1</sup>, C. Berggreen<sup>2</sup>, J. D. Sørensen<sup>3</sup>,  
G. Zhong<sup>4</sup>, W. Haans<sup>4</sup>

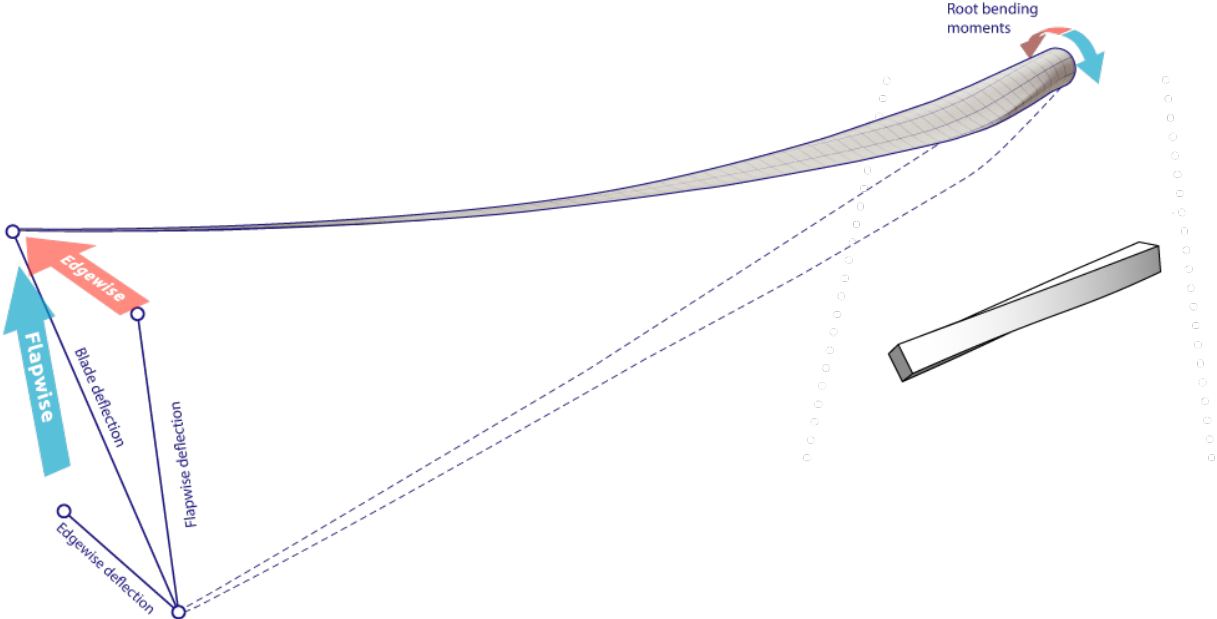
Figure 1. Flapwise and edgewise load components and tip deflection generate Root Torsional Moments (RTM). The orange arrow at the tip represents the edgewise aerodynamic tangential forces and the corresponding root bending moment at the root. The blue arrow at the tip represents the flapwise aerodynamic tangential forces and the corresponding root bending moment at the root. The arrows are representative, the forces act along the whole blade.

Figure 1 shows the three-dimensional tip deflection in both directions when the blade is in operation. This deflection is a consequence of the combination of flapwise loads due to the aerodynamic impact of

the incoming wind, and edgewise loads, due to gravity forces and blade dynamics during rotation. These movements cause forces to act not exactly at the blade's shear centre, thereby creating an arm that generates a Root Torsional Moment (RTM). The direction of this RTM depends on the magnitude of the applied loads and the stiffness of the blade. The load contributions that introduce a root torsional moment on the blade arise from the aerodynamic forces and gravity working on the already deformed blade under operation. As blades increase in length, the tip deflection also increases significantly, leading to notable rise in the RTM. This will be further discussed in the subsequent section of the paper.

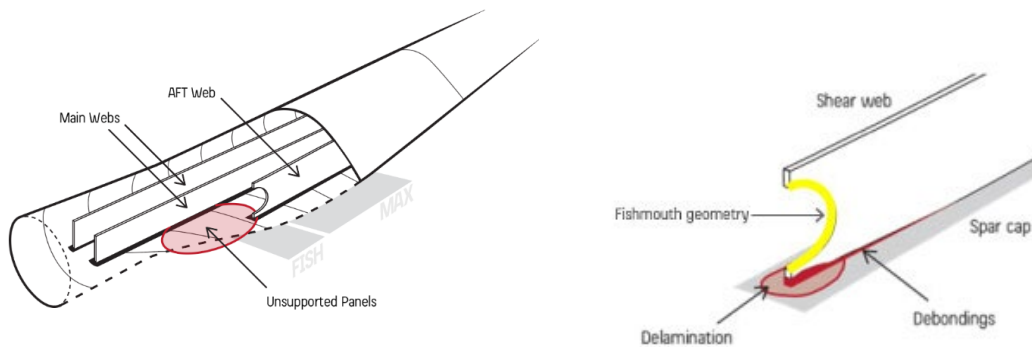
Figure 2. Transition zone of blade with 2 main shear webs and one aft shear web with unsupported panels, the red ellipse illustrating the area where the unsupported panels are located (left). Connection between the aft shear web fishmouth and the spar cap. Highlighted, initiation of delamination and debonding (right).

Seen from tip towards the root, the edgewise aerodynamic loads working on a flapwise deformed blade twist the blade in a clockwise direction and the flapwise loads generate a counterclockwise twist to the blade. The torsional load components cause localized panel deformations in the transition zone and in the max chord area of the blade (ref.[13.]). As a result of out-of-plane deformation, bending strains in the panels are generated. This occurs mainly in the transition zone and in the max chord area. The deformations also cause peeling stresses in the bondlines of blade designs with an aft shear web.

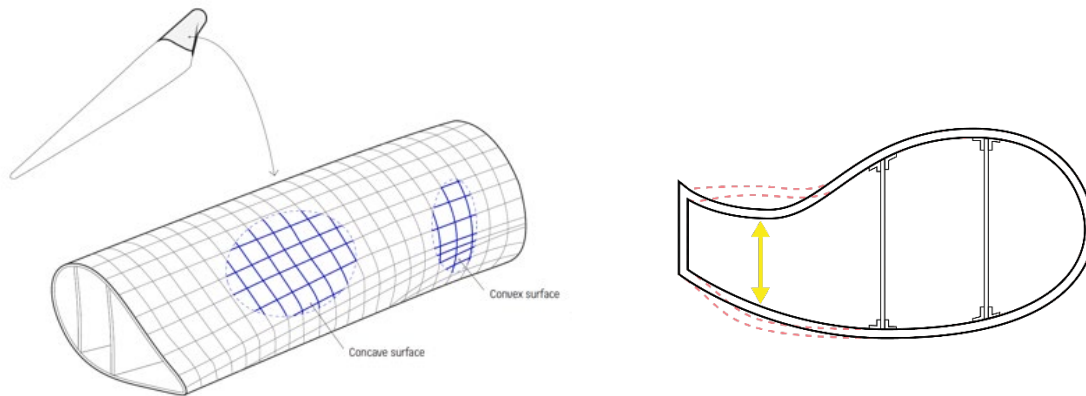
Figure 3. Transition zone of a large blade where the complex geometry can be appreciated, moving from a convex to concave shape, and changing in tapering in 3 directions. On the right, localized bending of the panels is represented, the solid lines represent the un-deformed positions, and the dashed lines present the deformed positions.

Localized bending of the sandwich panels in the transition zone (see Figure 3 for further information about the transition zone), often results in peeling in the bondlines of blade designs with an aft shear web. This occurs more frequently due to the peeling stresses caused by the out-of-plane deformation of the unsupported panels, which are carried by the bondlines of the aft shear web. In blades without an aft shear web, the peeling stresses are carried by the bondlines in the trailing edge and at the main shear web.

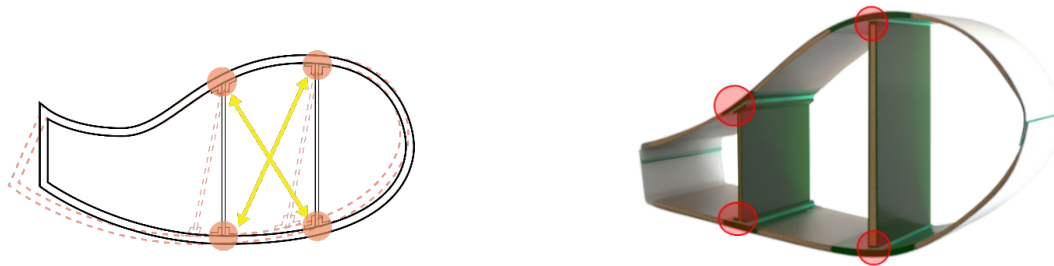
Figure 4. Blade cross-section. On the left, the solid lines represent the un-deformed position and the dashed lines show the deformed position. On the right, bondlines highlighted in red circles on a blade cross section.

Furthermore, the torsional loads cause additional cross-sectional shear distortion (CSSD), which results in additional peeling stresses (ref. [13.]) being transferred to the bondlines, see Figure 4. This phenomenon is in many cases driving structural related failures early in the lifetime of large wind turbine blades, see ref. [1]. In a previous study conducted by Bladena, it was concluded that both cross sectional shear distortion, and especially out-of-plane deformation of the panels in the transition zone, are the two main root causes of shear-web disbonding in the transition zone, see ref.[9].

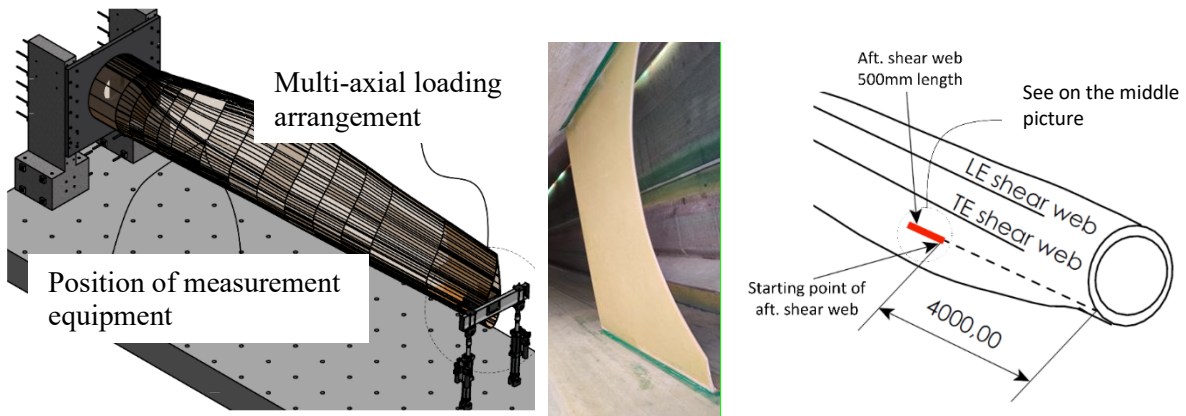
Figure 5. Large-scale strong-floor based test setup, the root section is mounted on a vertical strong-floor and the tip end is mounted onto the load train, the load introduction is explained on Figure 6 (left). Retrofitted aft shear installed in the 2 blade cut-outs (middle). The position of the retrofitted aft shear web illustrated (right).

The blade type used for this test campaign was a 34m blade manufactured by SSP Technology using a prepreg manufacturing process (pre-impregnated fiber mats without autoclave) (ref. [17.]). High resin content was selected for the laminates close to the PVC foam core and mold to ensure adequate resin quantity. According to the manufacturer a modification of the Ampreg 22 epoxy laminating system was used (ref. [18.]). Although, this blade type is considerably smaller than the blades typically discussed when addressing failure in the transition zone and newer blade designs are more likely to use balsa wood or PET foam for the core material. Despite, it is still sufficient to develop the test method and to demonstrate the effect of torsional loads with the use of right setup. A 15m root end section cut-out of the SSP34m blade was utilized with a retrofitted aft shear web in the transition zone. Since the blade originally has a box spar design, a retrofit aft shear web was necessary (ref. [15]). This web was installed 4m from the root towards the tip section, positioned midway between the load carrying box girder and the trailing edge. The position was determined based on previously conducted test results which indicated the highest out-of-plane deformation in this area, see ref. [1.]). The main body of the aft shear web is a sandwich structure consisting of a 10mm core material (PVC foam) and four layers of bi-axial glass fiber. The strong-floor setup and the retrofitted aft shear web are presented on the Figure 5.

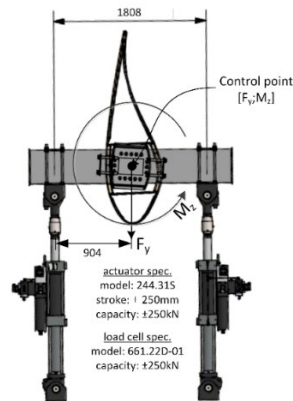
Figure 6. Active coordinate system and notation of the load train. Source: ref. [7]

The loading arrangement consists of two structural actuators which are capable of applying loads at the free end of the root section comprising two degree-of-freedom: edgewise load along with torsional moment around the longitudinal axis of the blade. The maximum loading used during this fatigue test was 100kN edgewise load component ( $F_Y$ ) and 100kNm as torsional moment ( $M_Z$ ) respectively and with a frequency of 0.1Hz. Figure 6 below shows the test setup actuator configuration of the loading at the 15m reinforced cross-section. More details about the test setup can be found in ref. [7]. Figure 6 illustrates the test setup and the actuator specifications with the related coordinate system. During the test campaign various instruments were used, including a Digital Image Correlation (DIC) system, 4 strain gauges mounted on the retrofitted aft shear web, acoustic emission sensors and a wire potentiometer, more details about the instrumentation (e.g., instrument specification, positioning, etc.) see in ref. [7.]. The illustration shows the mounted position of the blade on the test rig and visualizes the applied load components.

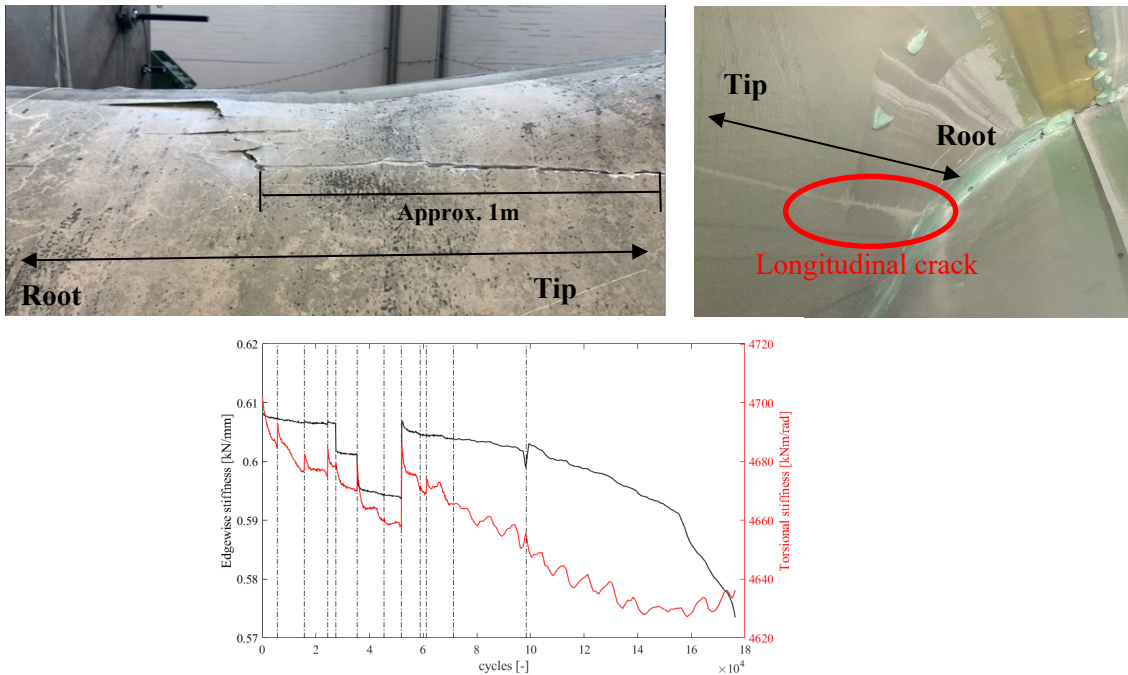
Figure 7. Picture presents the critical damage occurred on the 15m blade section of a 34m blade after 280.000 cycles in fatigue testing, where torsional loads are applied. The external condition of the blade (on the left), the crack observed internally (on the right). The length of the crack both internally and externally is around 1m. Plot presenting the change in edgewise and torsional stiffness (on the bottom).

The test resulted in a critical damage in the transition zone area on the pressure side panel in the trailing edge region of the blade in approx. 280.000 load cycles. More info about the damage and the test can be found in ref. [7.]. Further testing on the same blade section would have led to a blade collapse due to significant sudden decrease in edgewise stiffness (see Figure 7). This damage was a direct result of the applied torsional fatigue loads, causing large-scale damage on the blade shell in the root transition zone due to delamination from the out-of-plane deformation. The damage is shown on Figure 7. Such damage is considered critical, as it would require an immediate action if it happened during operation; failure to do so could potentially lead to further structural damage to the blade or other areas of the wind turbine. as if no actions were taken it could potentially lead to further structural damages on the blade or on other areas of the wind turbine.

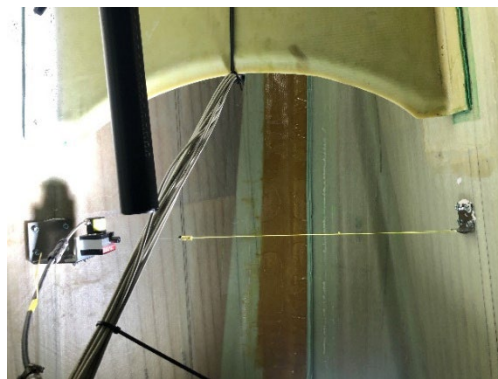
*Figure 8. The mounted wire potentiometer measured out-of-plane deformation of the blade panels. The potentiometer was installed 3.8m from the root and 200mm from the retrofitted aft shear web.*

The potentiometer installed 200mm from the front of the aft shear web towards the root (approximately 3.8m from the root) has captured out-of-plane deformations in the transition zone. Since the damage occurred further towards the root, the panel deformation is likely significantly higher where the panels are unsupported. At the position where the measurements were made, the aft shear web supported the blade shells which indicates that the out-of-plane deformation of the panels are likely lower in this area. The mounted wire potentiometer is presented in Figure 8 below.

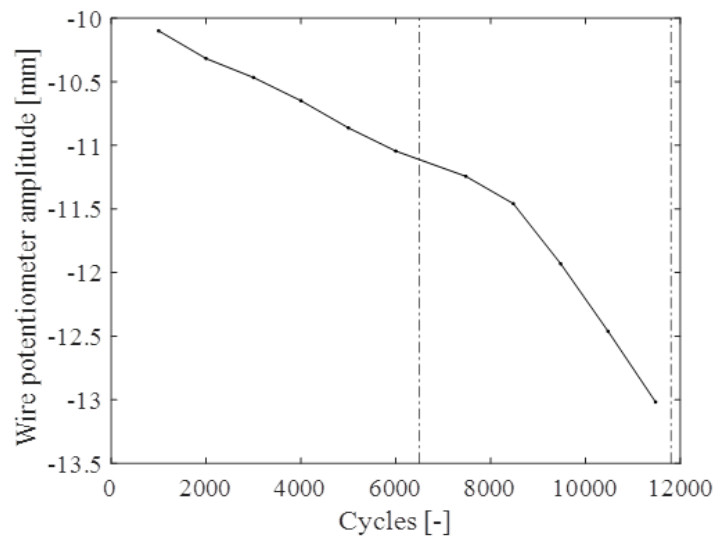
Figure 9. The measurements obtained from the wire potentiometer regarding out-of-plane deformation during the second test.

Additionally, a second 15m blade section of a SSP34m blade was tested with a 5cm crack introduced manually into the bondlines on both sides of the retrofitted aft shear web. The test was executed under the same conditions as the first fatigue test (100kN edgewise load component ( $F_Y$ ) and 100kNm torsional moment ( $M_Z$ ) with the frequency of 0.1Hz). However, the test was halted after approximately 12000 cycles due to technical issues with the mounting box girder installed onto the tip section of the blade which mounts the blade onto the test rig. During the 12000 cycles significant increase in out-of-plane deformation was observed, from the initial 10mm deformation, it increased to 13mm. as represented on Figure 9, below.

In Figure 9, a plot is presented of the magnitude of out-of-plane deformations and the nr. of cycles. A sudden drop (a drop in the plot shows an increase in the out-of-plane deformations) is observed on the plot at around 8000 cycles, show that damage is growing faster, hence is unstable. Upon inspecting the aft shear webs bondline, a clear crack propagation of over 10mm was observed on both bondlines of the aft shear web, see Figure 10.

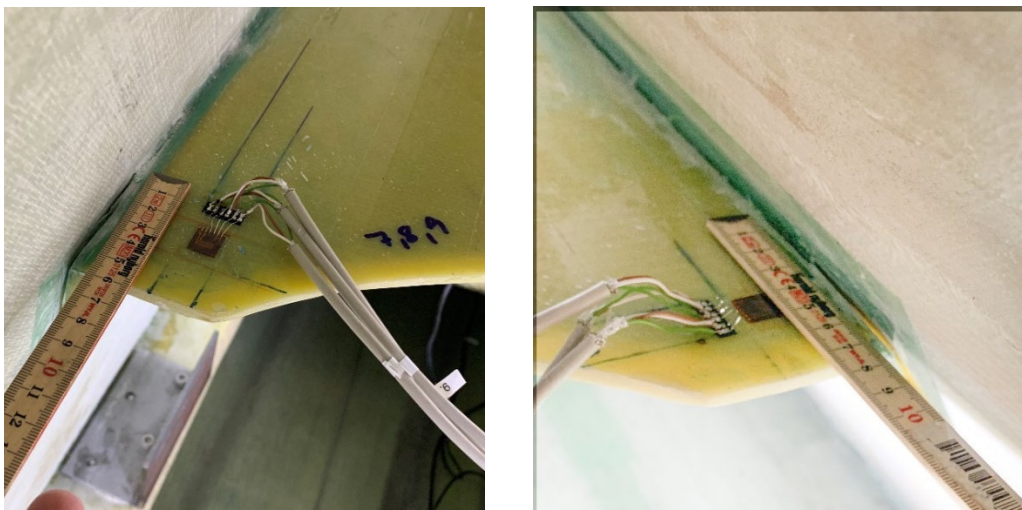
Figure 10. Approximately 10mm crack propagation on the Suction Side (on the left). Approximately 20mm crack propagation on the Pressure Side (on the right).

Figure 10 shows the results of inspection. A 10mm crack and a 20mm crack was observed on the SS and PS, respectively causing a halt to the testing.

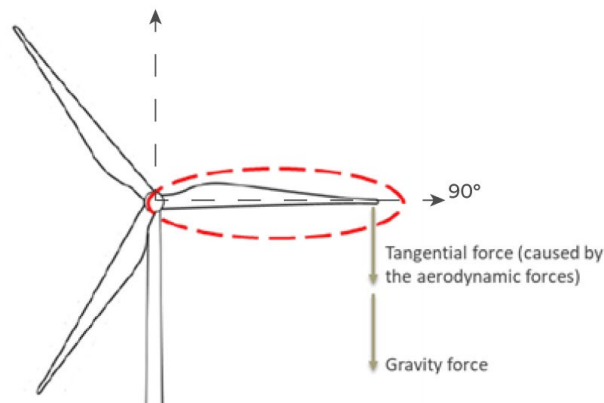
Figure 11. Investigated blade in 90-degree azimuthal position as the blade rotates. The arrows next to the forces indicate direction only, the gravity forces act at the center of gravity of the blade whereas the tangential forces (caused by the aerodynamic forces) act along the blade.

Each hotspot is analysed for the blade position where the highest values were found. Two operational load positions, 90-degree azimuthal position and 270-degree azimuthal position have been used. To clarify this, the azimuthal degree indicates the position of the blade during rotation. As an example, 0-degree represents a blade in a vertical position with the tip pointing up, and 180-degree azimuthal position the blade is also vertical with the tip facing down. For further details, see Figure 11.

As also mentioned in the introduction section, the load contributions that introduce a root torsional moment on the blade arise from the aerodynamic forces and gravity working on the already deformed blade under operation. The aerodynamic forces can be divided in a purely flapwise component as well as a tangential component in relation to the rotor plane, acting as an edgewise load, in relation to the aerodynamic profile of the blade. Additionally, gravitational loads are also acting in the edgewise direction, see Figure 11.

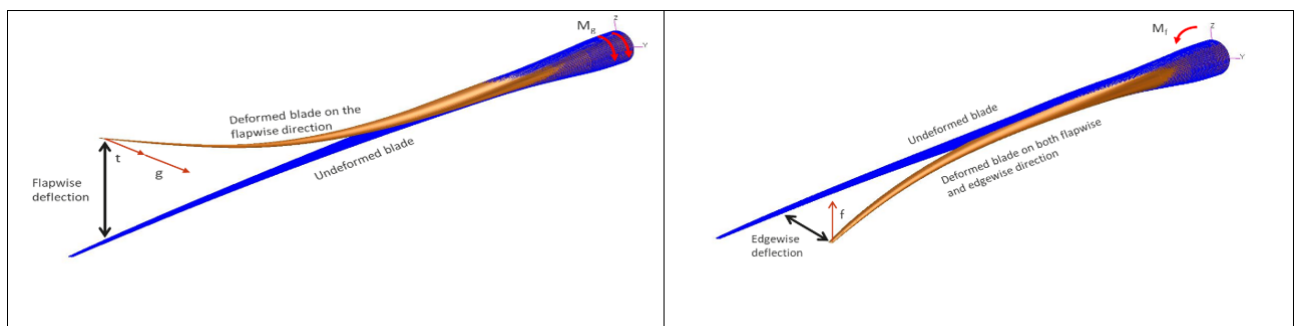
Figure 12. Left: RTM when gravity and tangential forces are in the same direction. Right: Root Torsional Moment induced by flapwise forces. Moment is acting in a different direction than the ones from the edgewise loads. On the figures “t” indicates tangential force and “M” indicates torsional moment.

When the blade is loaded and deflected, torsional loads are generated. The edgewise aerodynamic loads working on a flapwise deformed blade twist the blade in a clockwise direction if the blade is seen from the tip towards the root. At the same time aerodynamic flapwise loads work on the edgewise deflected blade and the twist direction generated by this depends on the direction of the edgewise deflection. While the tangential aerodynamic loads (if the aerodynamic loads are split into two, based on directions, we can define normal direction and tangential direction) are always working towards LE, the gravitational load switch direction relative to the blade between the two horizontal positions. Figure 9 shows 90-degree azimuthal position where the aerodynamic tangential forces and gravity works in the same direction. For this position the flapwise loads generate a counterclockwise twist to the blade when seen from tip towards the root. Figure 10 illustrates the resulting torsional moments due to the operational loads.

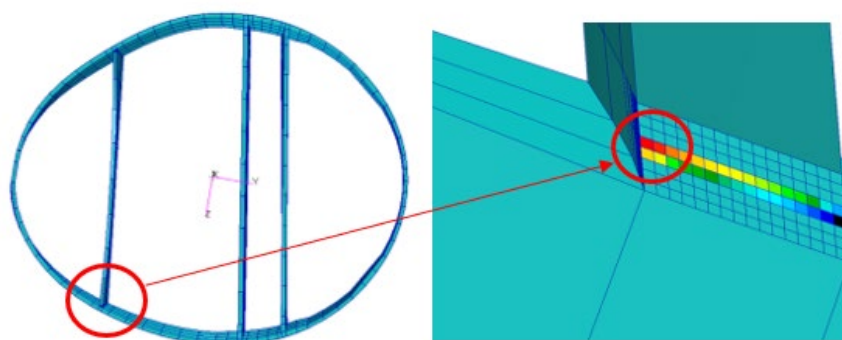
*Figure 13. An example of the location where peeling stresses are extracted. The cross section is of a root-transition zone area and the peeling stresses are extracted at the aft shear web fish mouth foot as highlighted in red circle. The illustration is an indication of the increased peeling stresses in the investigated area.*

Figure 13 below shows an example of where the peeling stresses are extracted from the 3D-solid FEM analysis.

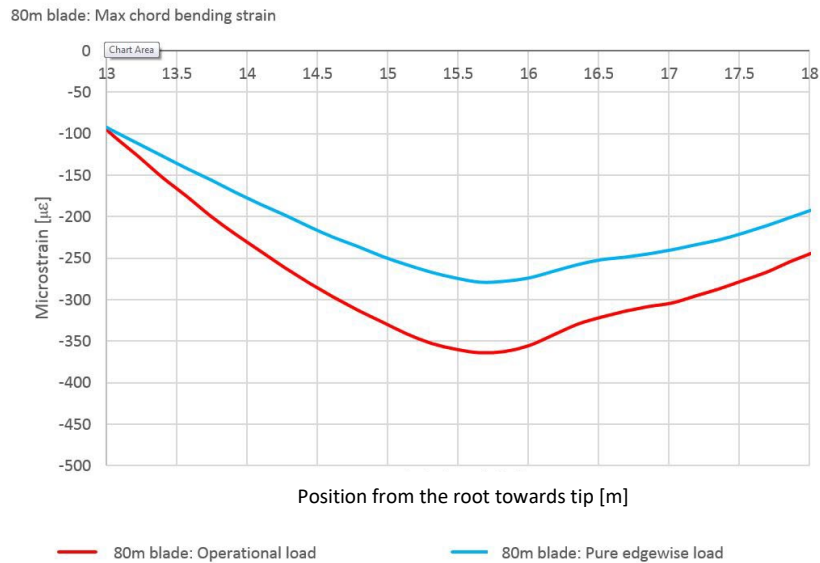
Figure 14. Bending strain comparison for the 80m blade in the max chord area. Operational loads 90-degree azimuthal position vs Only Edgewise loads.

For the max chord area Table 10 shows that bending strains increase around 30% whenever torsional loads are included.

It is also important to highlight that values for operational conditions are lower in the max chord area ( $360\mu\epsilon$ ) than in the transition zone ( $450\mu\epsilon$ ) which strengthens the hypothesis that the transition zone is the most critical and sensitive area from a structural point of view.

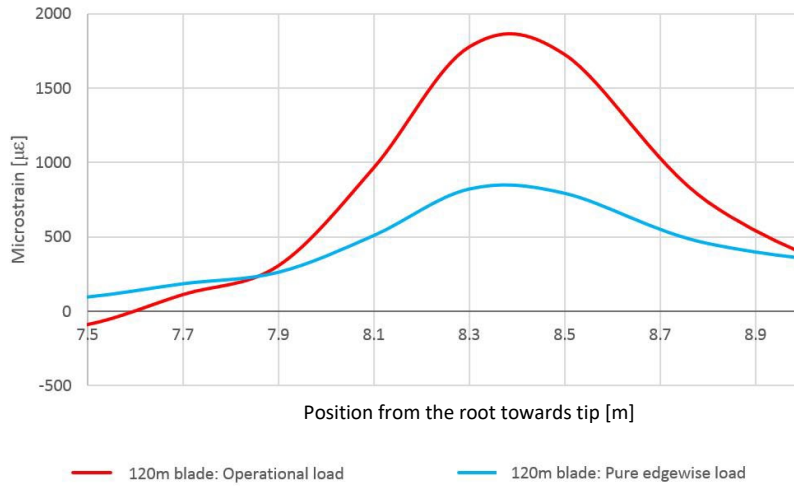
Figure 15. Bending strain comparison for 120m blade in the transition zone PS, operational load 270-degree azimuthal position max values vs Pure edgewise load max values.

Table 11 also indicates that bending of the panels is more severe in a 120m than in the 80m blade, shown in table 9. The difference in bending strains with operational loads reaches a +40% (630µε vs 450µε).

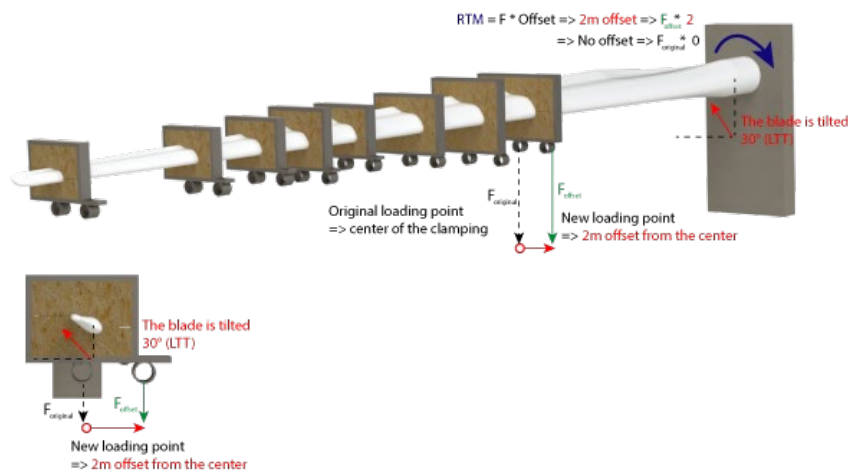
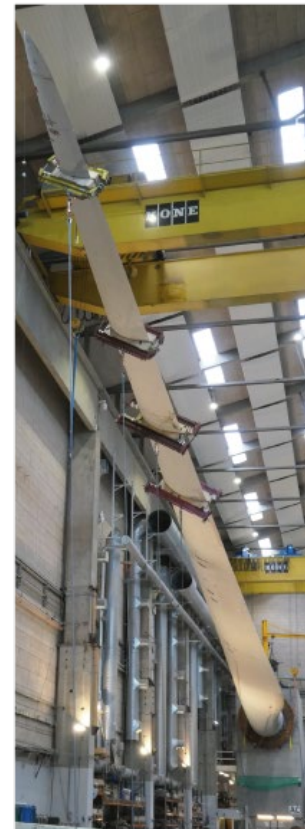
Figure 16: Sketch of a full-scale static test setup with applied torsional load components (left). Photo to the right show a full-scale test of a LM58,7m blade with combined static loads performed at a commercial test center in collaboration with LM-Windpower and Bladena, see ref. [1] EUDP RATZ project.

If the combination of loads were applied, with an offset, shown on the sketch in Fig. 18, the local deformations and distortion effects (CSSD and breathing) will be representative. To incorporate the combined flap- and edgewise loads, the blade was tilted 30 degrees in the direction of the leading edge toward trailing edge during the full-scale test performed in an earlier executed full-scale blade test study, see ref. [1]. At this full-scale test, the purpose was also to test the buckling capacity of the trailing edge. In this paper the focus is on the structural strength of the max chord region and the root transition zone and therefore the sketch show another load direction, in the positions where the torsional loads are highest.

This full-scale static test campaign is fast and easy to perform, and the costs are low. Furthermore, the additional load case can be done before the certification fatigue test program is started, and this is important since the measurement, is needed as early, as possible in order to validate FEM-models. When the FEM model is validated the boundaries for of the performed fatigue test sub-component program, can be updated.
